Manhole Inspection Summary

Manhole # S2701_010MH

Insp Date: **2/25/08 9:41 AM**

Location Address: **2826 Sethlow Road**

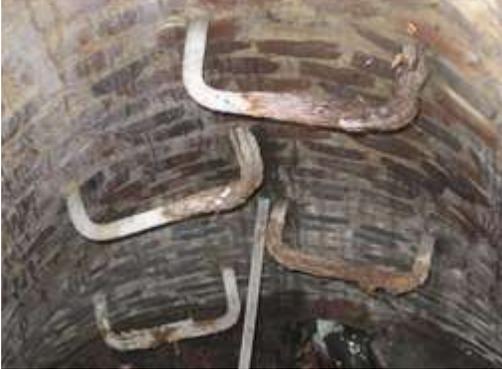
Steps Count: **4** Missing: **0** **Corroded**

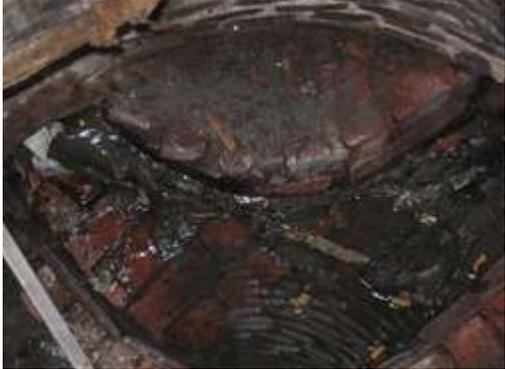
Defect 2

Condition: Sound Cracked Root Intrusion Deteriorated Leaks **Debris**

Channel (inflow)

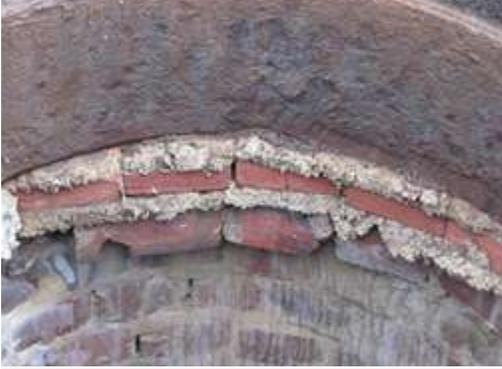
Defect 1

Condition: Sound Cracked Root Intrusion **Loose Brick** Deteriorated

Infiltration: None Joint Cracks **Mortar** Roots Wall

Infiltration

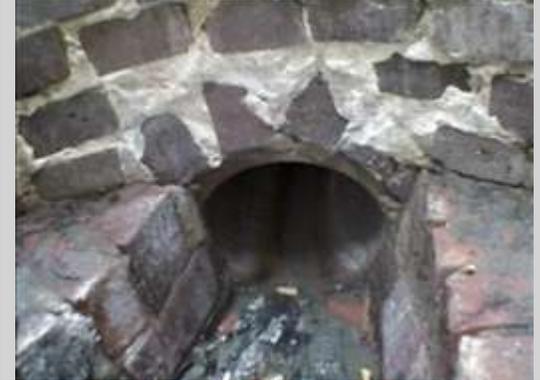
12 O'Clock Outflow

8 in. Circular Gravity Sewer
Pipe Out @ 12 O'Clock

Pipe Height: **9.6** (in.) Rod and Bar (Angled)
Pipe Material: **Clay** Pipe Lined
Invert Depth: **8.09** (ft.) Flow Characteristics: **Slow**
Deposits: None Mud Sludge Debris Grease
Silt Depth: (in.) Deposits Extent:
Infiltration: **None** Pipe Seal Cond: **Sound**

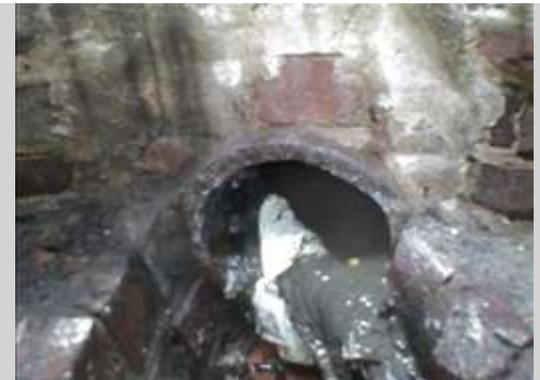
9 O'Clock Inflow

6 in. Circular Gravity Sewer
Pipe In @ 9 O'Clock

Pipe Height: **6** (in.) Rod and Bar (Angled)
Pipe Material: **Clay** Pipe Lined
Invert Depth: **7.45** (ft.) Flow Characteristics: **Slow**
Deposits: None Mud Sludge Debris Grease
Silt Depth: (in.) Deposits Extent:
Infiltration: **None** Pipe Seal Cond: **Sound**
